HYVA QUILL SHAFT

Partno.:

021313010

Type of Gearbox	
VOLVO	VT2014...VTO2814B VT2414B I-SHIFT+RETARDER VOITH

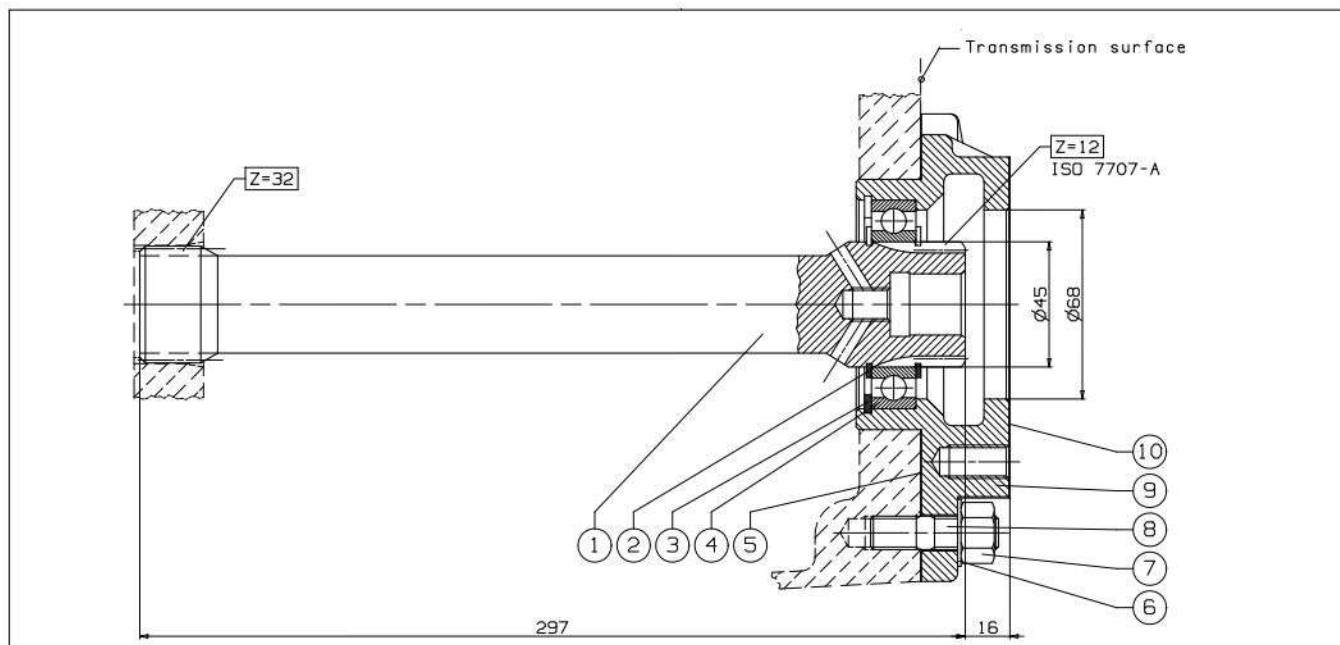
Parts list			
No.	Partno.:	Description	Qty.
1		Quill shaft	1
2		Circlip E 45	1
3		Circlip 75 I	1
4		Ball bearing 45x75x16	1
5		Gasket	1
6		Washer	4
7		Nut M12 CH17 H12	4
8		Stud M12x27 UNI 5911	4
9		Shift-PTO coupling flange	1
10		Gasket	1

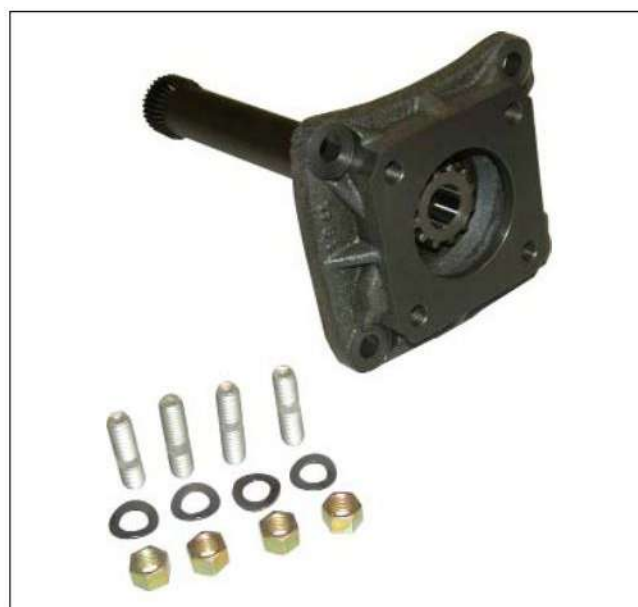
In some cases the VOLVO transmission can have a lubrication hole for the PTO. In this case, pay particular attention to correct gasket orientation.

In the mounting phase of the flange onto the gearbox, check the integrity of the OR seal incorporated into the rear surface of the gearbox hatch. If it has deteriorated, replace it with the seal included in our shaft kit.
